**Flood Control Project Maintenance  
Levee Inspections****LMA District Cover Sheet  
Spring 2016 Levee Inspection Results****Reclamation District No. 0827 Elkhorn**

**Spring 2016 Levee Inspection Results**

**Reclamation District No. 0827 Elkhorn**

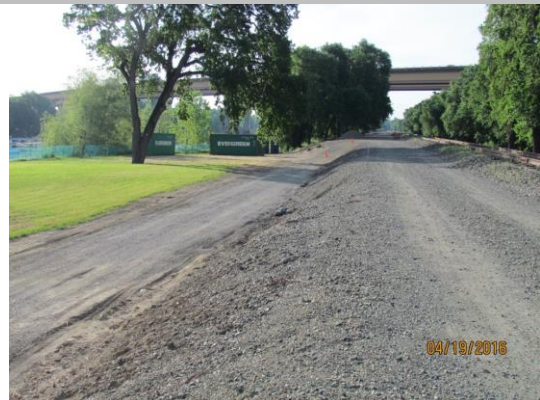
Photo 1 of 1 : SP\_2016\_RD0827\_187\_4\_20160419\_00010.jpg

LM Start	0.03	Rating **	A	Issue No.	4
LM End	0.61	Issue Type +	Ma	Location *	WS
Category	Earthen Levee			GPS Latitude/Longitude	
				Start	End
Item	Vegetation			38.674862 °	38.668954 °
				-121.630072 °	-121.622552 °
DWR ID	DWR_RD0827_01_s_2016_4				
Comment Code					
V1 : Control annual grass and weeds on the levee slopes and easements.					
Inspector Comment					
LMA has maintained levee slopes.

View of the vegetation on the waterward slope of the levee looking downstream. Spring 2016.

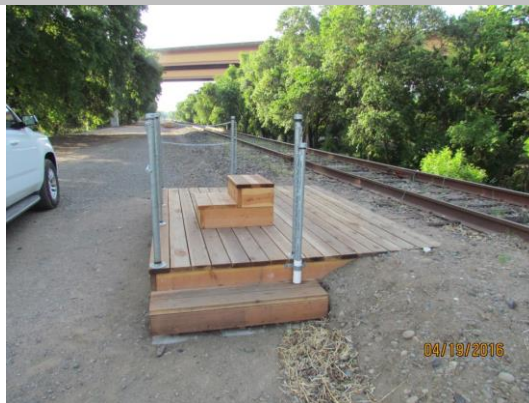
Photo 1 of 1 : SP\_2016\_RD0827\_187\_10\_20160419\_00011.jpg

LM Start	0.11	Rating **	U	Issue No.	10
LM End	0.11	Issue Type +	En	Location *	CR
Category	Earthen Levee			GPS Latitude/Longitude	
				Start	End
Item	Encroachments			38.674133 °	38.674133 °
				-121.629097 °	-121.629097 °
DWR ID	DWR_RD0827_01_s_2016_10				
Comment Code					
ST : Stairway					
Inspector Comment					
Railroad has put steps on the crown for the tourist train from the West City of Sac water plant. Stairs are not permitted and was placed this year Spring 2016.

View of the stairs on the crown of the levee looking downstream. Spring 2016.

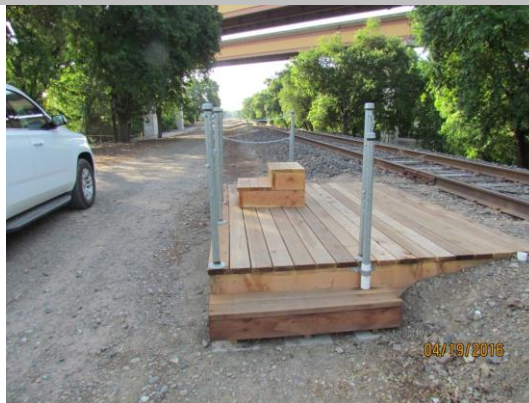
Photo 1 of 1 : SP\_2016\_RD0827\_187\_11\_20160419\_00012.jpg

LM Start	0.14	Rating **	U	Issue No.	11
LM End	0.14	Issue Type +	En	Location *	CR
Category	Earthen Levee			GPS Latitude/Longitude	
				Start	End
Item	Encroachments			38.673803 °	38.673803 °
				-121.628675 °	-121.628675 °
DWR ID	DWR_RD0827_01_s_2016_11				
Comment Code					
ST : Stairway					
Inspector Comment					
Railroad has put steps on the crown for the tourist train from the West City of Sac water plant. Stairs are not permitted and was placed this year Spring 2016.

View of the stairs on the crown of the levee looking downstream. Spring 2016.

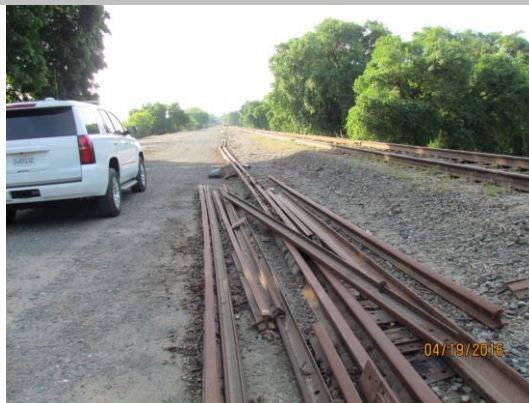
Photo 1 of 1 : SP\_2016\_RD0827\_187\_12\_20160419\_00013.jpg

LM Start	0.24	Rating **	M	Issue No.	12
LM End	0.53	Issue Type +	En	Location *	CR
Category	Earthen Levee			GPS Latitude/Longitude	
				Start	End
Item	Encroachments			38.672749 °	38.669781 °
				-121.627333 °	-121.623587 °
DWR ID	DWR_RD0827_01_s_2016_12				
Comment Code					
EQ : Equipment					
Inspector Comment

View of the rails on the crown of the levee looking downstream. Spring 2016.

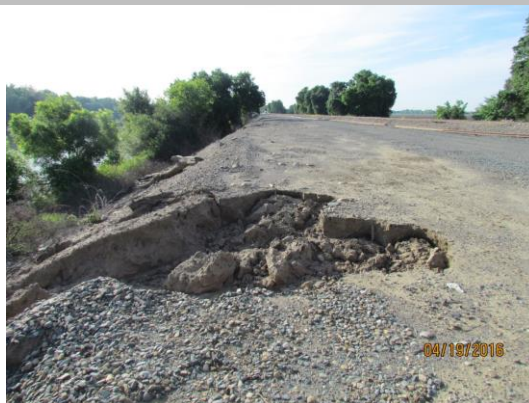
Photo 1 of 1 : SP\_2016\_RD0827\_187\_109\_20160419\_00014.jpg

LM Start	0.28	Rating **	U	Issue No.	109
LM End	0.28	Issue Type +	Ma	Location *	WS
Category	Earthen Levee			GPS Latitude/Longitude	
				Start	End
Item	Erosion / Bank Caving			38.672406 °	38.672406 °
				-121.626828 °	-121.626828 °
DWR ID	DWR_RD0827_01_s_2014_109				
Comment Code					
E1 : Note and monitor erosion site.					
Inspector Comment

View of the erosion on the shoulder of the landward side of the levee looking downstream. Spring 2016.

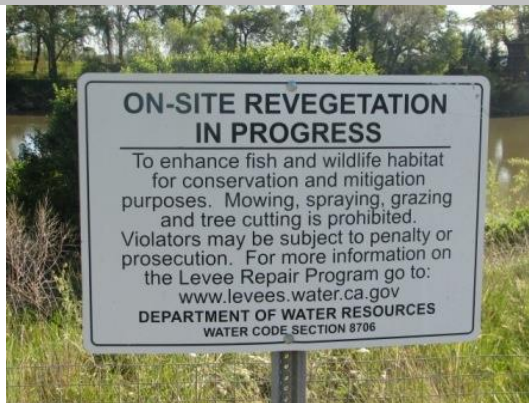
Photo 1 of 2 : SP\_2016\_RD0827\_187\_22\_20160304\_00003.jpg

LM Start	0.61	Rating **	A/W	Issue No.	22
LM End	0.92	Issue Type +	Ma	Location *	WS
Category	Earthen Levee			GPS Latitude/Longitude	
				Start	End
Item	Vegetation			38.668873 °	38.665750 °
				-121.622513 °	-121.618523 °
DWR ID	DWR_RD0827_01_s_2012_22				
Comment Code					
V8 : Environmental Requirements.					
Inspector Comment

Revegetation site spring 2012.

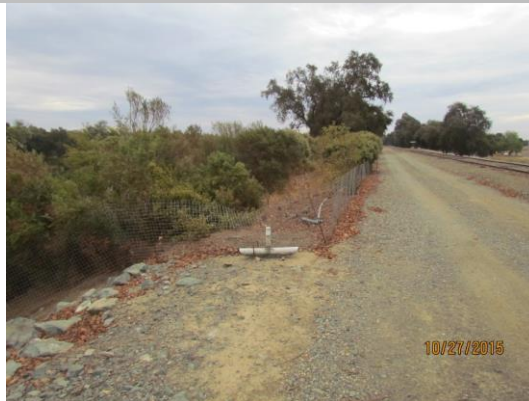
Photo 2 of 2 : SP\_2016\_RD0827\_187\_22\_20160304\_00004.jpg

View of the revegetation site on the waterward side of the levee looking downstream. Fall 2015.

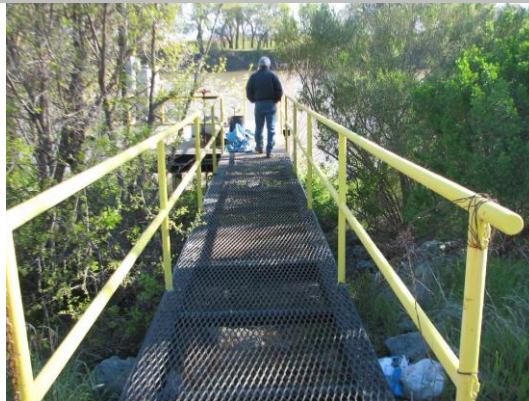
Photo 1 of 2 : UCIP\_SP\_2016\_38983\_59737.jpg

FS\_ID:38983  
DS\_ID:21147  
EP\_NO: N/A  
Repair Type: Non-Urgent  
Crossing Status: Found  
UCIP Comments: Need to contact owner to obtain additional information for this crossing. This crossing does not match original description listed in desk study. Need to coordinate with owner to obtain permit number authorizing modification.  
FIELD\_STRUCT\_DESC: 14-inch (not 16-inch as listed in desk study) pipe through the levee, 10.3 feet below the crown. 10-inch bypass pipe on waterward side. Siphon breaker on landward (not waterward) shoulder. Pump on platform (not mounted on 48-inch concrete pipe as described in desk study) on waterward bank. Metal (not wooden) walkway to the pump. 3/4-inch conduit through levee at unknown depth.  
FS Date: 3/18/2014

Platform for pump located on waterward side.

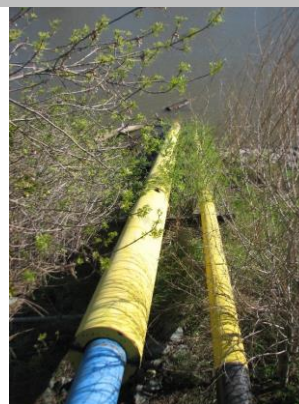
Photo 2 of 2 : UCIP\_SP\_2016\_38983\_59736.jpg

Pipe visible on waterward side.

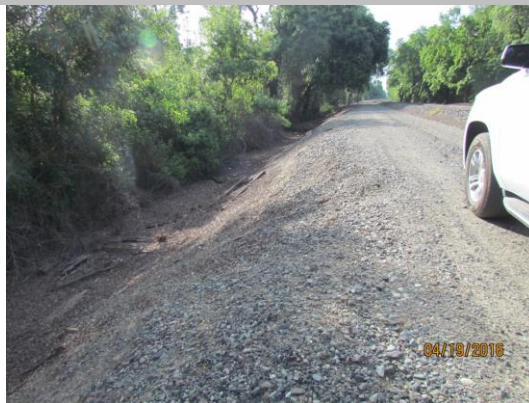
Photo 1 of 1 : SP\_2016\_RD0827\_187\_213\_20160419\_00016.jpg

LM Start	0.96	Rating **	M	Issue No.	213
LM End	0.96	Issue Type +	Ma	Location *	WS
Category	Earthen Levee			GPS Latitude/Longitude	
				Start	End
Item	Slope Stability			38.665307 °	38.665307 °
				-121.617982 °	-121.617982 °
DWR ID	DWR_RD0827_01_s_2015_213				
Comment Code					
S1 : Repair slope instability.					
Inspector Comment

View of the slope stability on the waterward side of the levee looking downstream. Spring 2016.

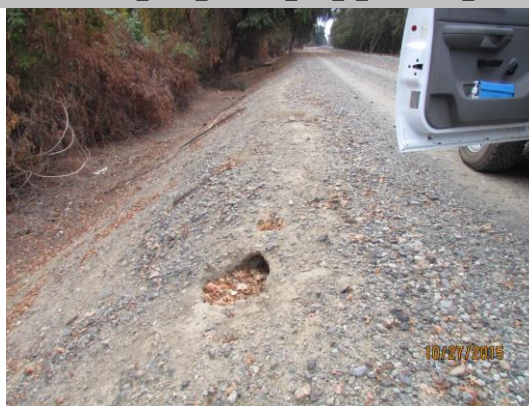
Photo 1 of 1 : SP\_2016\_RD0827\_187\_8\_20160304\_00002.jpg

LM Start	0.97	Rating **	M	Issue No.	8	
LM End	0.97	Issue Type +	Ma	Location *	WS	
Category	Earthen Levee			GPS Latitude/Longitude		
				Start		End
Item	Animal Control			38.665213 °		38.665213 °
				-121.617886 °		-121.617886 °
DWR ID	DWR_RD0827_01_f_2015_8					
Comment Code						
A3 : No rodents visible, but rodent burrows visible; need to backfill and compact or grout burrows.						
Inspector Comment

View of the rodent hole on the waterward side of the levee looking downstream. Fall 2015.

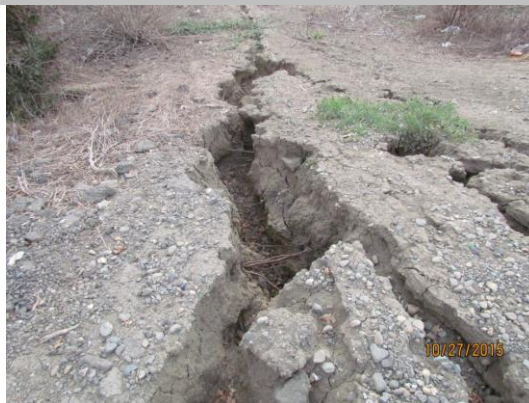
Photo 1 of 2 : SP\_2016\_RD0827\_188\_10\_20160304\_00005.jpg

LM Start	0.02	Rating **	U	Issue No.	10
LM End	0.02	Issue Type +	Ma	Location *	LS
Category	Earthen Levee			GPS Latitude/Longitude	
				Start	End
Item	Erosion / Bank Caving			38.676549 °	38.676549 °
				-121.642703 °	-121.642703 °
DWR ID	DWR_RD0827_02_f_2015_10				
Comment Code					
E2 : Schedule repair of erosion site prior to the next inspection.					
Inspector Comment					
It seems like someone poured water onto the levee slope and caused an erosion on the slope.

It seems someone poured a large amount of water over the levee slope and caused the erosion. Fall 2015.

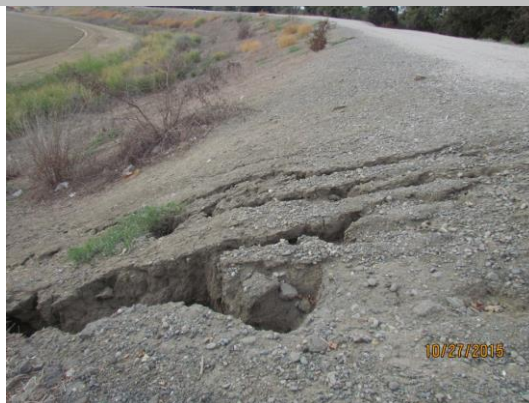
Photo 2 of 2 : SP\_2016\_RD0827\_188\_10\_20160304\_00006.jpg

View of the erosion on the landward side of the levee looking downstream. Fall 2015.

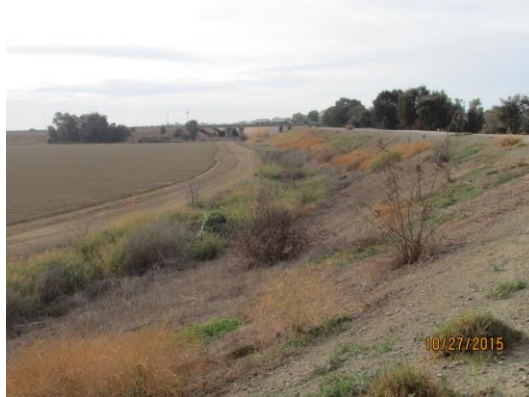
Photo 1 of 1 : SP\_2016\_RD0827\_188\_2\_20160304\_00001.jpg

LM Start	0.02	Rating **	M	Issue No.	2
LM End	0.52	Issue Type +	En	Location *	LS
Category	Earthen Levee			GPS Latitude/Longitude	
				Start	End
Item	Encroachments			38.676440 °	38.669401 °
				-121.642747 °	-121.641417 °
DWR ID	DWR_RD0827_02_f_2012_2				
Comment Code					
DT : Ditch					
Inspector Comment

View of the ditch on the landward side of the levee looking downstream. Fall 2015.

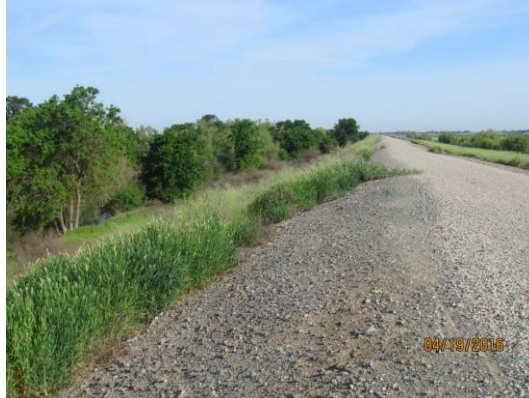
Photo 1 of 1 : SP\_2016\_RD0827\_188\_15\_20160419\_00023.jpg

LM Start	0.03	Rating **	M	Issue No.	15	
LM End	2.72	Issue Type +	Ma	Location *	WS	
Category	Earthen Levee			GPS Latitude/Longitude		
				Start		End
Item	Vegetation			38.676442 °		38.642003 °
				-121.642779 °		-121.620938 °
DWR ID	DWR_RD0827_02_s_2016_15					
Comment Code						
V1 : Control annual grass and weeds on the levee slopes and easements.						
Inspector Comment

View of the vegetation on the waterward side of the levee looking upstream. Spring 2016.

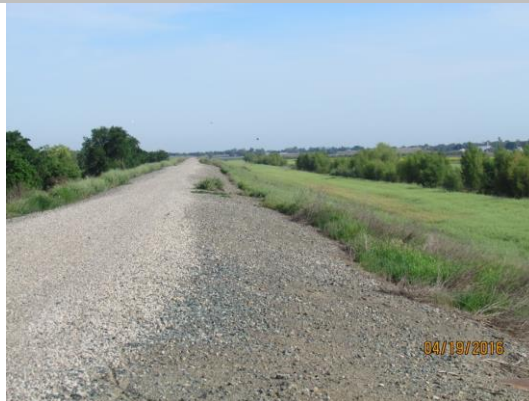
Photo 1 of 1 : SP\_2016\_RD0827\_188\_16\_20160419\_00024.jpg

LM Start	0.29	Rating **	M	Issue No.	16
LM End	2.72	Issue Type +	Ma	Location *	LS
Category	Earthen Levee			GPS Latitude/Longitude	
				Start	End
Item	Vegetation			38.672796 °	38.642004 °
				-121.642242 °	-121.620937 °
DWR ID	DWR_RD0827_02_s_2016_16				
Comment Code					
V1 : Control annual grass and weeds on the levee slopes and easements.					
Inspector Comment

View of the vegetation on the landward side of the levee looking upstream. Spring 2016.

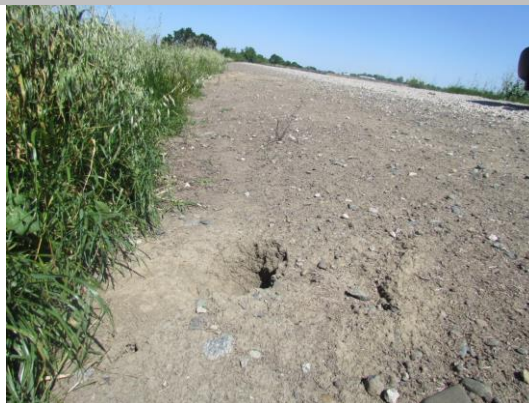
Photo 1 of 1 : SP\_2016\_RD0827\_188\_390\_20160304\_00010.jpg

LM Start	0.64	Rating **	M	Issue No.	390
LM End	0.64	Issue Type +	Ma	Location *	WS
Category	Earthen Levee			GPS Latitude/Longitude	
				Start	End
Item	Animal Control			38.667880 °	38.667880 °
				-121.640587 °	-121.640587 °
DWR ID	DWR_RD0827_02_s_2015_390				
Comment Code					
A3 : No rodents visible, but rodent burrows visible; need to backfill and compact or grout burrows.					
Inspector Comment

View of the burrow on the water ward side of the levee looking upstream. Spring 2015.

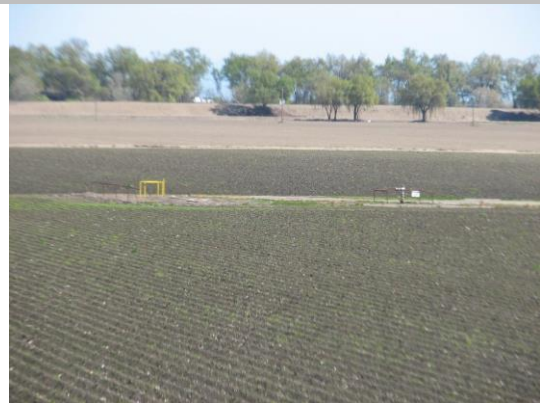
Photo 1 of 2 : UCIP\_SP\_2016\_38982\_59662.jpg

LM Start	1.04	Rating **	U	Issue No.	393
LM End	1.04	Issue Type +	En	Location *	WS
Category	Supplemental			GPS Latitude/Longitude	
				Start	End
Item	DWR UCIP Field Study			38.662955 °	38.662955 °
				-121.636489 °	-121.636489 °
DWR ID					
Comment Code					
Inspector Comment					
FS_ID:38982					
DS_ID:24844					
EP_NO: 17403					
Repair Type: Urgent					
Crossing Status: Indicator Found					
UCIP Comments: No markers visible on either banks. Need to contact owner to determine status of crossing. Need date of last inspection and confirmation that crossing is still in operable condition.					
FIELD_STRUCT_DESC: 2.375-inch diameter steel natural gas pipeline across and under (bored) the left (east) bank levee of Yolo Bypass and Tule Canal. (Permit No. 17403-2007)					
FS Date: 3/18/2014

Appurtenances for gas line located approximately 993 feet from levee crown.

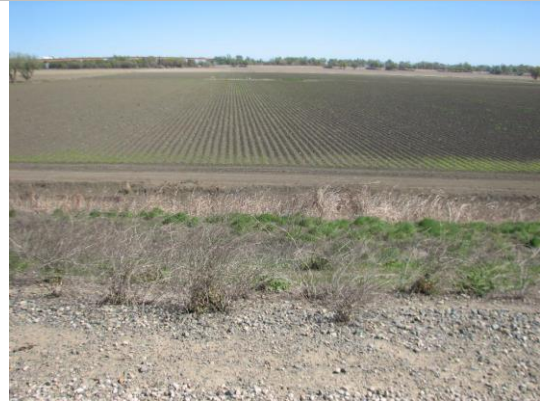
Photo 2 of 2 : UCIP\_SP\_2016\_38982\_59661.jpg

LM Start	1.04	Rating **	U	Issue No.	393 (cont)	
LM End	1.04	Issue Type +	En	Location *	WS	
Category	Supplemental			GPS Latitude/Longitude		
				Start		End
Item	DWR UCIP Field Study			38.662955 °		38.662955 °
				-121.636489 °		-121.636489 °
DWR ID						
Comment Code						
Inspector Comment						
FS_ID:38982						
DS_ID:24844						
EP_NO: 17403						
Repair Type: Urgent						
Crossing Status: Indicator Found						
UCIP Comments: No markers visible on either banks. Need to contact owner to determine status of crossing. Need date of last inspection and confirmation that crossing is still in operable condition.						
FIELD_STRUCT_DESC: 2.375-inch diameter steel natural gas pipeline across and under (bored) the left (east) bank levee of Yolo Bypass and Tule Canal. (Permit No. 17403-2007)						
FS Date: 3/18/2014

View of landward side.

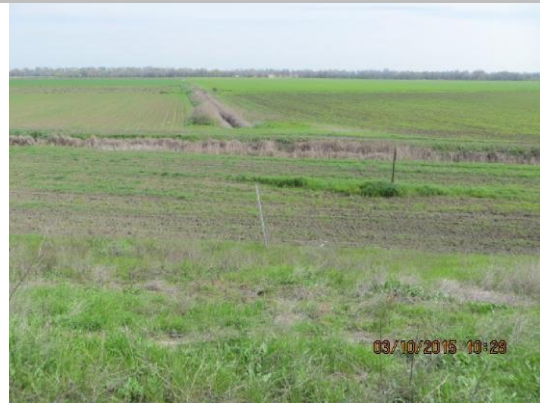
Photo 1 of 2 : UCIP\_SP\_2016\_43843\_73360.jpg

LM Start	2.03	Rating **	U	Issue No.	395	
LM End	2.03	Issue Type +	En	Location *	WS	
Category	Supplemental			GPS Latitude/Longitude		
				Start		End
Item	DWR UCIP Field Study			38.651052 °		38.651052 °
				-121.626501 °		-121.626501 °
DWR ID						
Comment Code						
Inspector Comment						
FS_ID:43843 DS_ID:21159 EP_NO: 15904 Repair Type: Urgent Crossing Status: Indicator Found UCIP Comments: Sign missing on WS and LS. Need to confirm status of crossing with permittee. Appears abandoned. FIELD_STRUCT_DESC: 3-inch steel pipe through the levee, 20.0 feet below the crown. Sign on waterward side. Yellow pipe visible east of ditch appr. 150 ft off LS toe. (Permit No. 15904-1992) FS Date: 3/10/2015

View of LS.

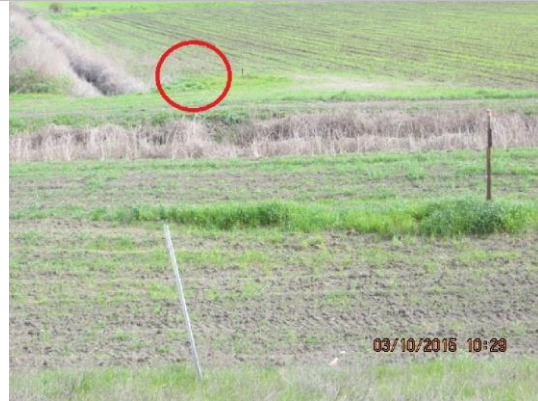
Photo 2 of 2 : UCIP\_SP\_2016\_43843\_73361.jpg

LM Start	2.03	Rating **	U	Issue No.	395 (cont)
LM End	2.03	Issue Type +	En	Location *	WS
Category	Supplemental			GPS Latitude/Longitude	
				Start	End
Item	DWR UCIP Field Study			38.651052 °	38.651052 °
				-121.626501 °	-121.626501 °
DWR ID					
Comment Code					
Inspector Comment					
FS_ID:43843 DS_ID:21159 EP_NO: 15904 Repair Type: Urgent Crossing Status: Indicator Found UCIP Comments: Sign missing on WS and LS. Need to confirm status of crossing with permittee. Appears abandoned. FIELD_STRUCT_DESC: 3-inch steel pipe through the levee, 20.0 feet below the crown. Sign on waterward side. Yellow pipe visible east of ditch appr. 150 ft off LS toe. (Permit No. 15904-1992) FS Date: 3/10/2015

Pipe visible east of ditch appr. 150 ft off LS toe.

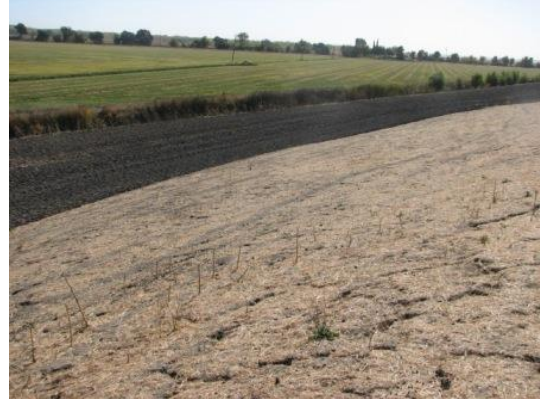
Photo 1 of 1 : SP\_2016\_RD0827\_188\_24\_20160304\_00008.jpg

LM Start	2.29	Rating **	M	Issue No.	24
LM End	2.29	Issue Type +	Ma	Location *	LS
Category	Earthen Levee			GPS Latitude/Longitude	
				Start	End
Item	Slope Stability			38.647703 °	38.647703 °
				-121.624450 °	-121.624450 °
DWR ID	DWR_RD0827_02_s_2012_24				
Comment Code					
S1 : Repair slope instability.					
Inspector Comment					
Cracking along the levee slope is less than 200 feet in length. Monitor the slope for changes in cracking.

A buldge in the levee slope. Photo fall 2012.

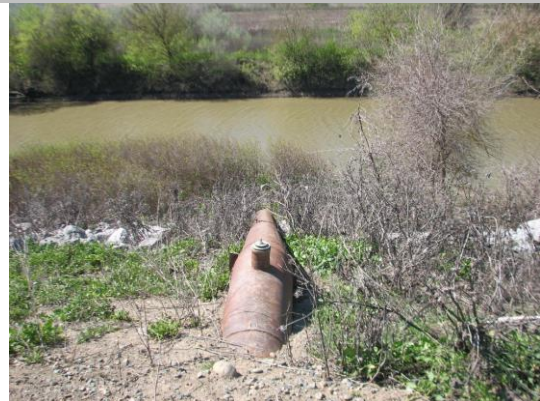
Photo 1 of 2 : UCIP\_SP\_2016\_38984\_59769.jpg

Comment Code					
Inspector Comment					
FS_ID:38984 DS_ID:21151 EP_NO: 3277 Repair Type: Non-Urgent Crossing Status: Found UCIP Comments: Crossing appears to have been removed and replaced under maintenance back in 2008. No permit has been found--need to contact owner to obtain additional information about replacement. Landward slope sloughing--does not appear to be associated with crossing. Landward slope is being monitored by LMA. FIELD_STRUCT_DESC: 18-inch (not 20-inch as noted in desk study) steel drainpipe through the levee, 4.0 feet below the crown. Cutoff wall around pipe at center of levee. Siphon breaker on apex of pipe at waterward shoulder. Pump on pipe structure in drainage ditch at landward toe. Rock revetment on waterward slope. Pipe retained through levee and updates required to crossing under Permit No. 3277 (1960). FS Date: 3/18/2014

View of pipe visible on waterward side.

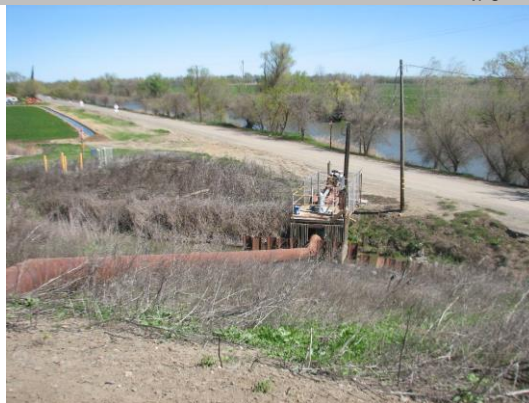
Photo 2 of 2 : UCIP\_SP\_2016\_38984\_59768.jpg

Comment Code					
Inspector Comment					
FS_ID:38984 DS_ID:21151 EP_NO: 3277 Repair Type: Non-Urgent Crossing Status: Found UCIP Comments: Crossing appears to have been removed and replaced under maintenance back in 2008. No permit has been found--need to contact owner to obtain additional information about replacement. Landward slope sloughing--does not appear to be associated with crossing. Landward slope is being monitored by LMA. FIELD_STRUCT_DESC: 18-inch (not 20-inch as noted in desk study) steel drainpipe through the levee, 4.0 feet below the crown. Cutoff wall around pipe at center of levee. Siphon breaker on apex of pipe at waterward shoulder. Pump on pipe structure in drainage ditch at landward toe. Rock revetment on waterward slope. Pipe retained through levee and updates required to crossing under Permit No. 3277 (1960). FS Date: 3/18/2014

View of landward side.

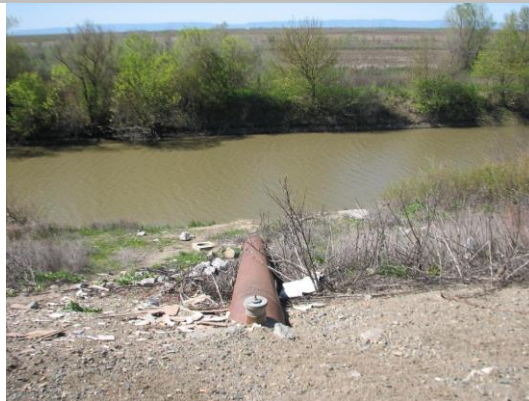
Photo 1 of 2 : UCIP\_SP\_2016\_33032\_59778.jpg

FS\_ID:33032  
DS\_ID:21169  
EP\_NO: 5611  
Repair Type: Non-Urgent  
Crossing Status: Found  
UCIP Comments: Crossing appears to have been removed and replaced under maintenance back in 2008. No permit has been found--need to contact owner to obtain additional information about replacement.  
FIELD\_STRUCT\_DESC: [RD No. 827 Pumping Plant] 22-inch (not 24-inch as mentioned in desk study) steel drainpipe through the levee, 8.0 feet below the crown. CM cutoff wall around pipe at center of levee. Siphon breaker on waterward slope. Flap gate on waterward end. Pipe is exposed along waterward slope. (USACE-1955). This entry matches the Drainage or Irrigation Structure referenced in O&M manual (Station 3+75). Portion of pipe was removed and replaced, from landward side to waterward shoulder, under Permit No. 5611 (1968).  
FS Date: 3/18/2014

Pipe exposed on waterward side.
